## VEHICLE INSPECTION REPORT

**FJ72VRP**

### Mercedes-Benz eVito 66 85KW Progressive

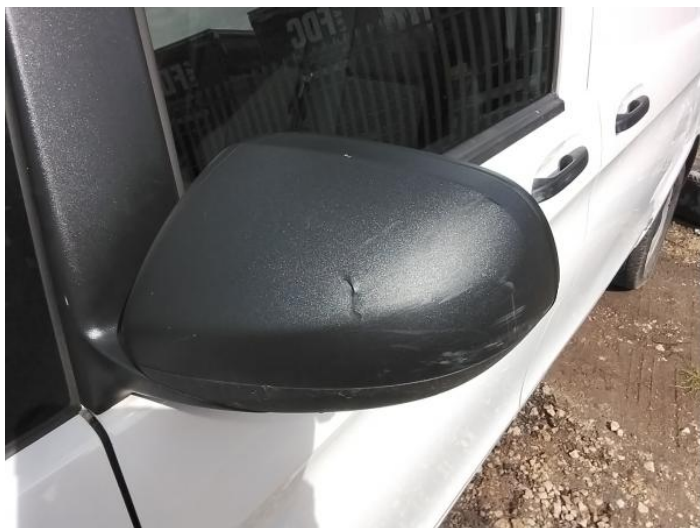
1: Door Mirror Assy nsf  
Broken  
Replace

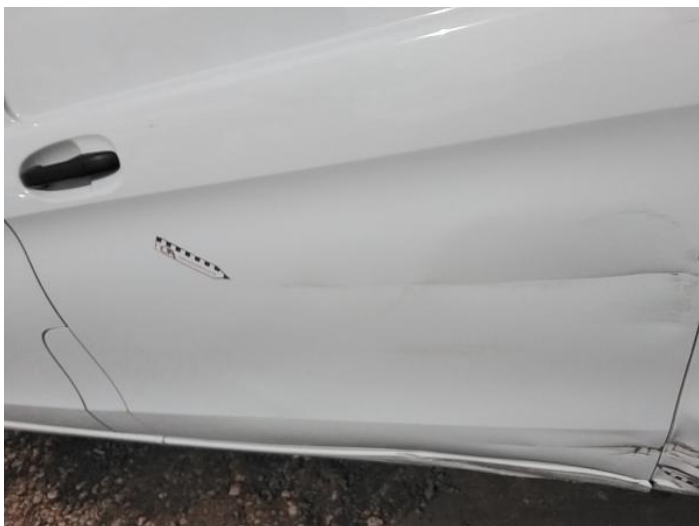
3: Qtr Panel nsr  
Dented  
Over 30mm

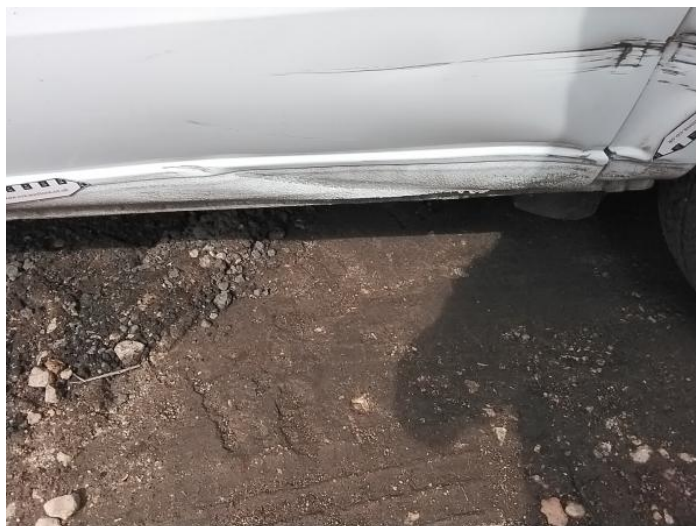
4: Sill ns  
Dented  
Over 30mm

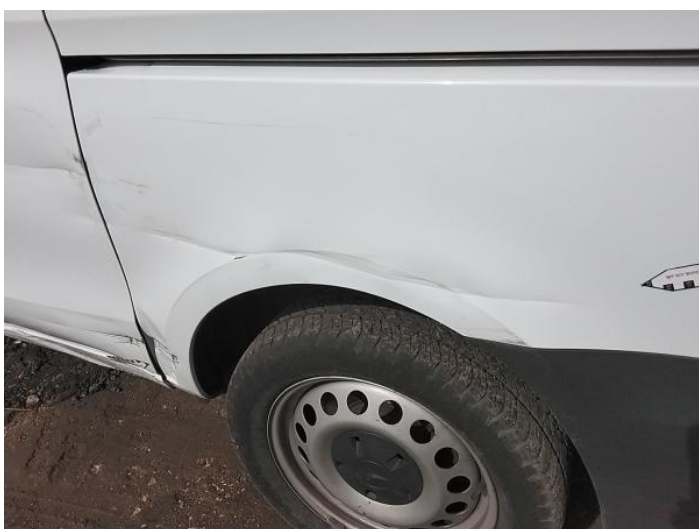
5: Qtr Panel nsr  
Dented  
Over 30mm

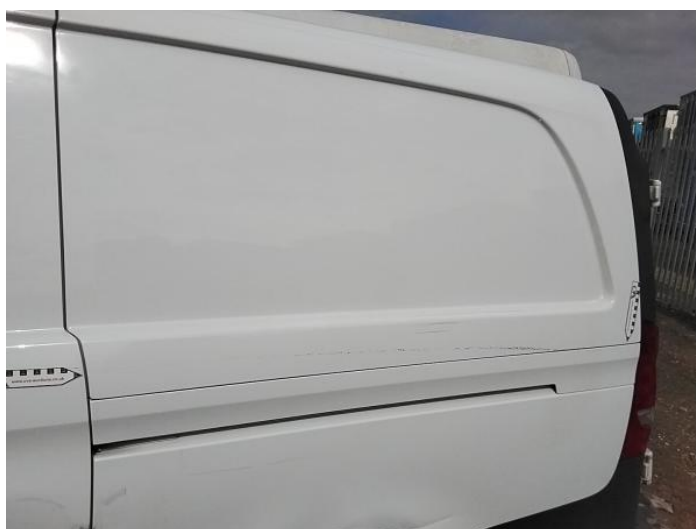
6: Qtr Panel nsr  
Scratched  
Over 25mm Not Thru Paint

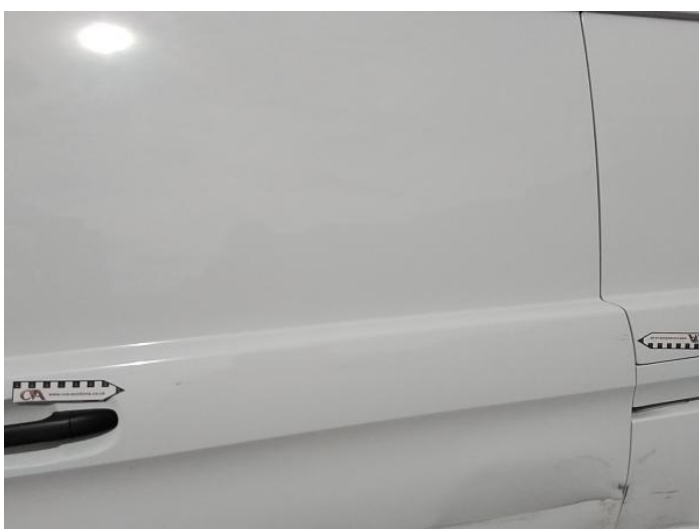
7: Qtr Panel nsr  
Scratched  
Over 25mm Not Thru Paint

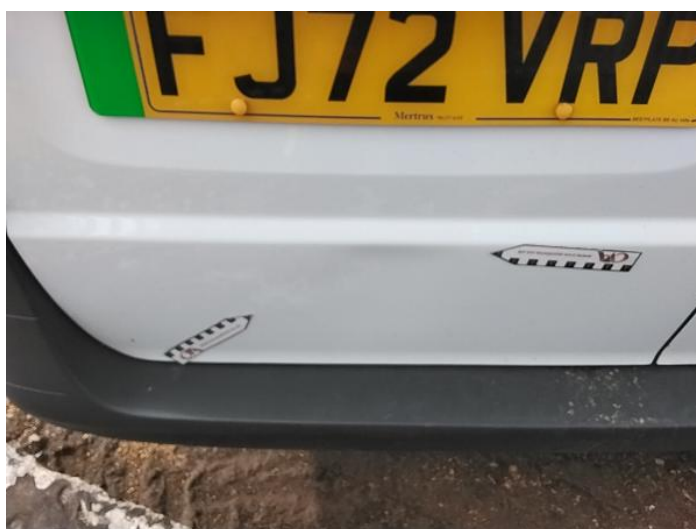
8: Door nsr  
Dented  
Over 30mm

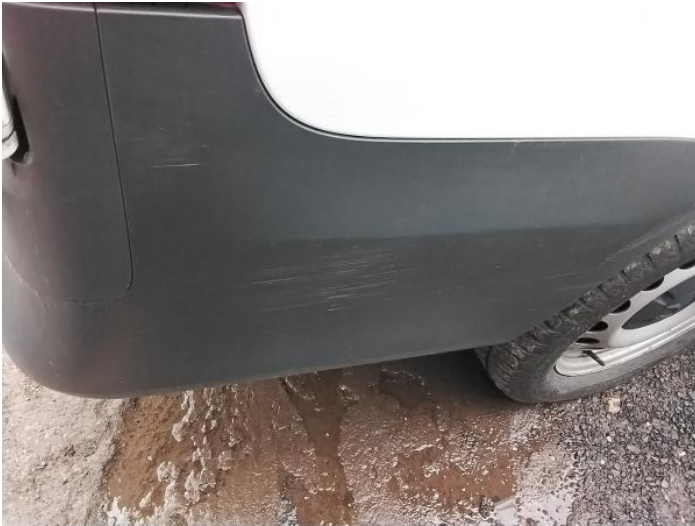
9: Bumper Rear Moulding  
Scuffed (Unpainted)  
Over 100mm

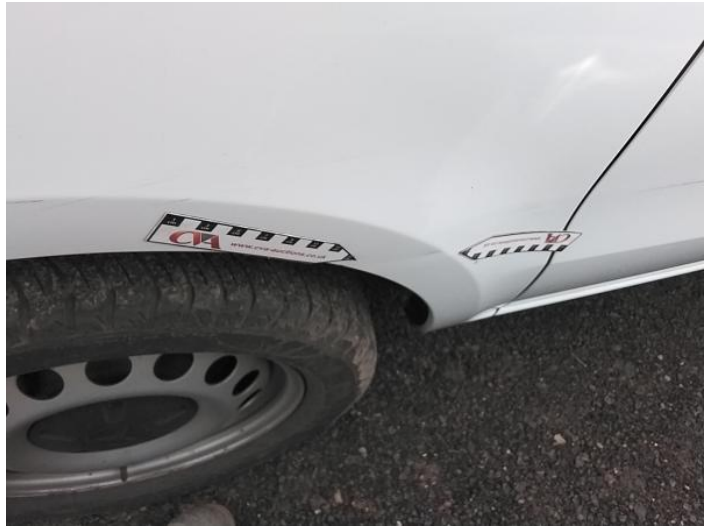
10: Qtr Panel osr  
Dented  
Over 30mm

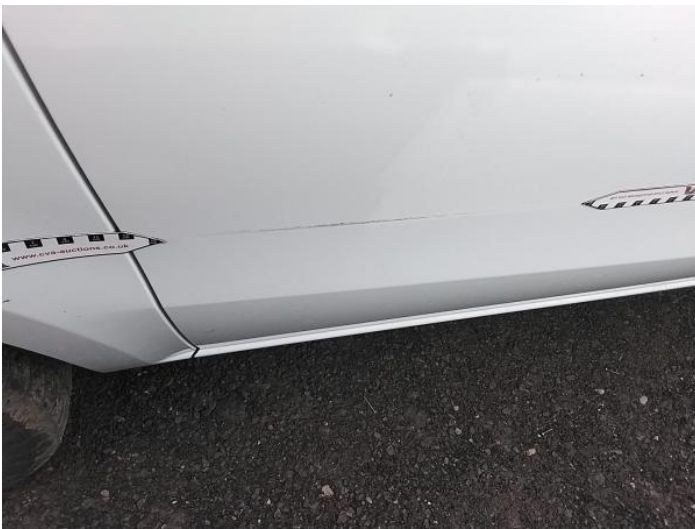
11: Qtr Panel osr  
Scratched  
Over 25mm Not Thru Paint

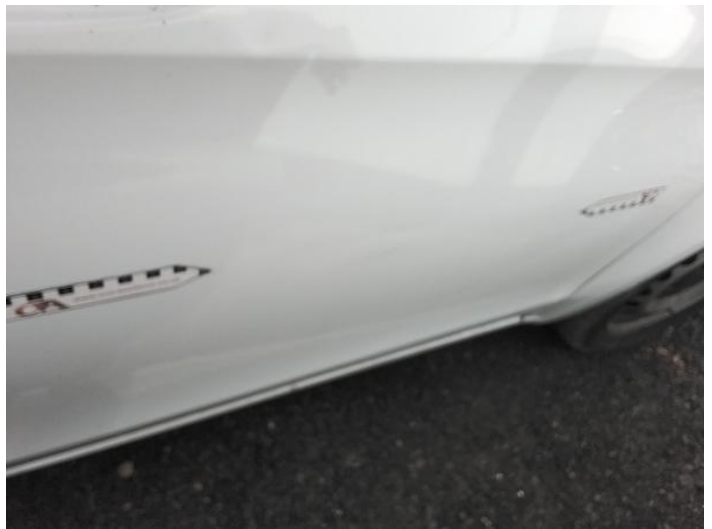
12: Door osf  
Dented  
Over 30mm

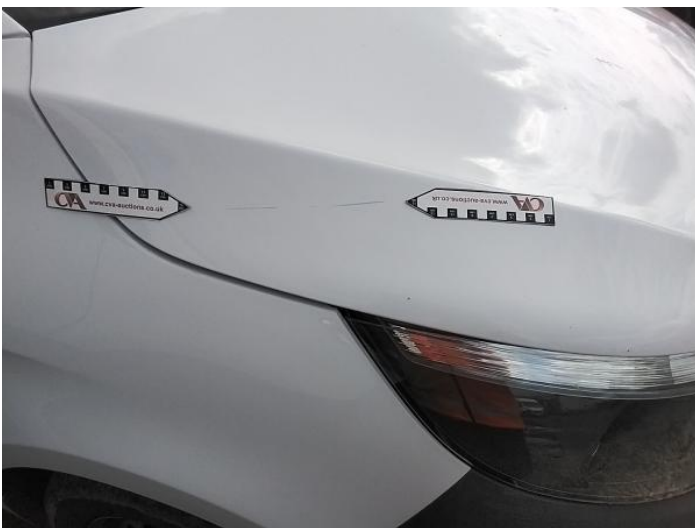
13: Bonnet  
Scratched  
Over 25mm Not Thru Paint

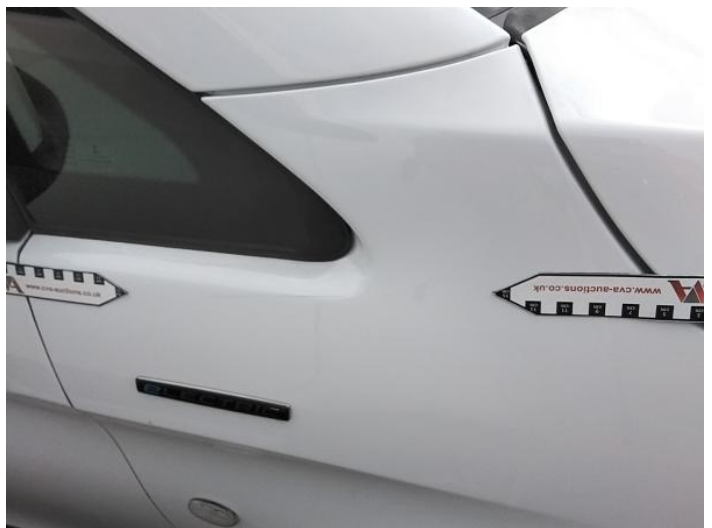
14: Wing osf  
Scratched  
Over 25mm Not Thru Paint

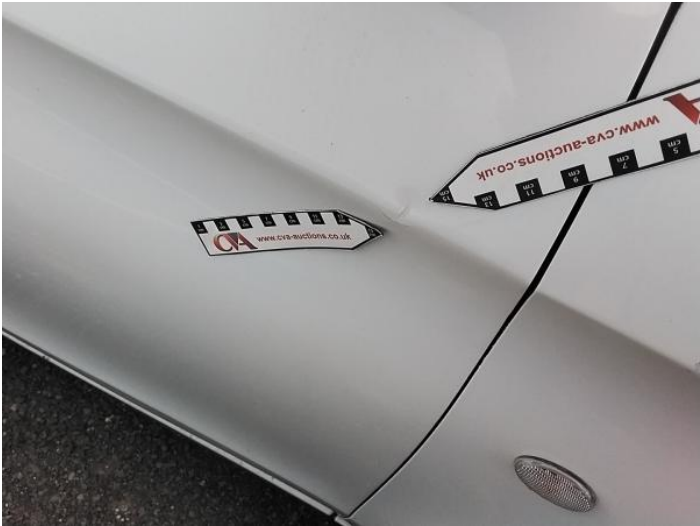
15: Door osf  
Dented  
Between 10mm + 30mm
