# VEHICLE INSPECTION REPORT

**DK17LUY**

## Man TGS 26.360

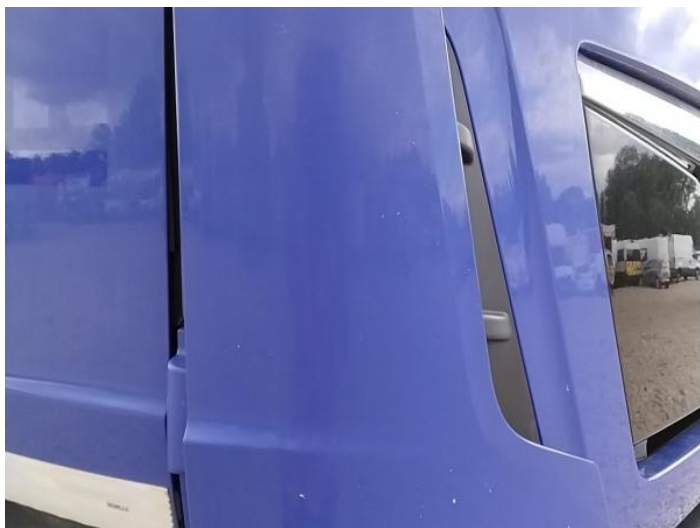
1: Wing of  
Chipped  
Multiple Chips

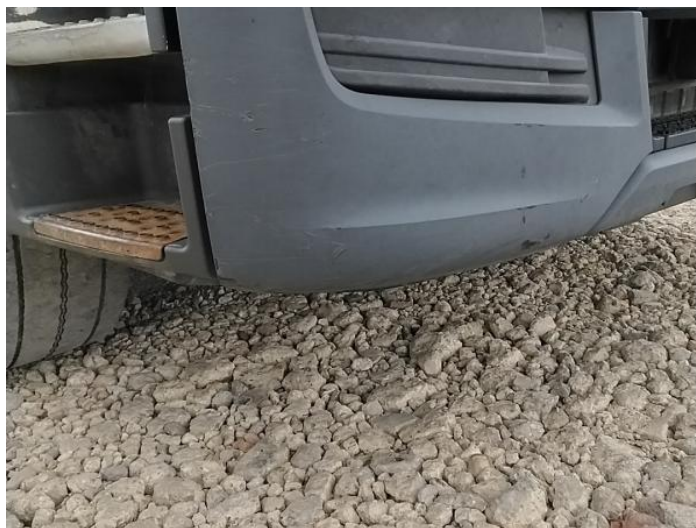
2: Bumper Front Moulding  
Scuffed (Unpainted)  
Up To 100mm

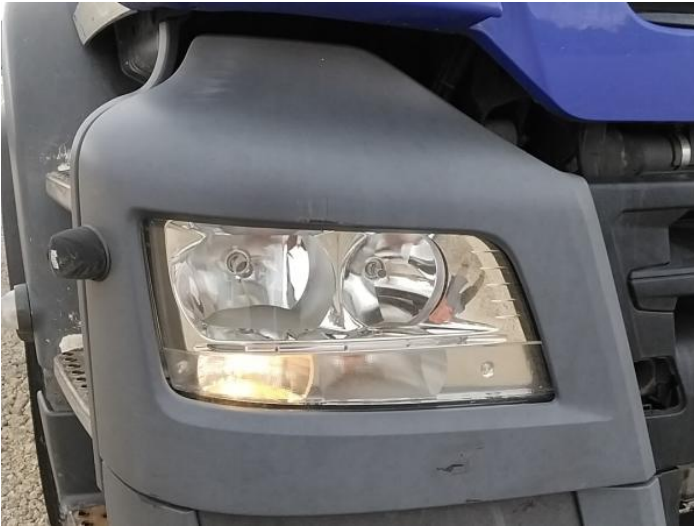
3: Fog Lamp Surround os  
Scuffed (Unpainted)  
UpTo 100mm

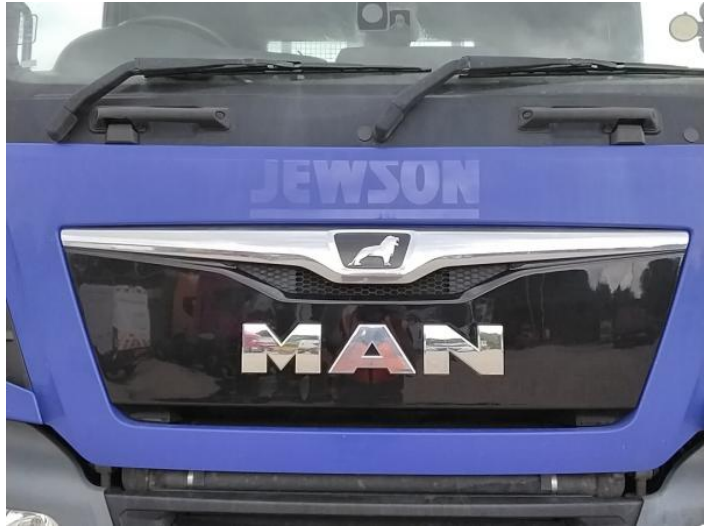
4: Bonnet  
Chipped  
Multiple Chips

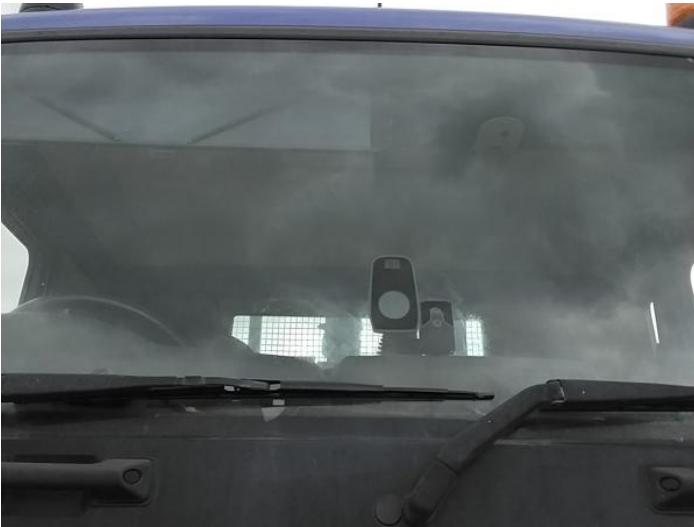
5: Screen Front  
Chipped  
UpTo 10mm

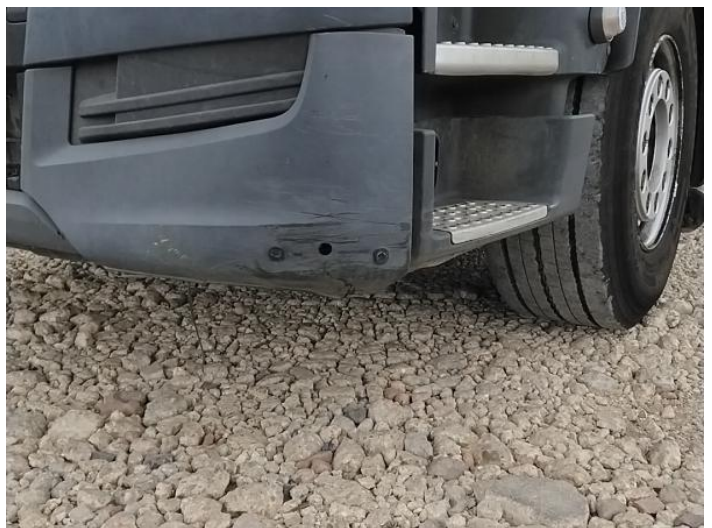
8: Bumper Front Moulding  
Scuffed (Unpainted)  
UpTo 100mm

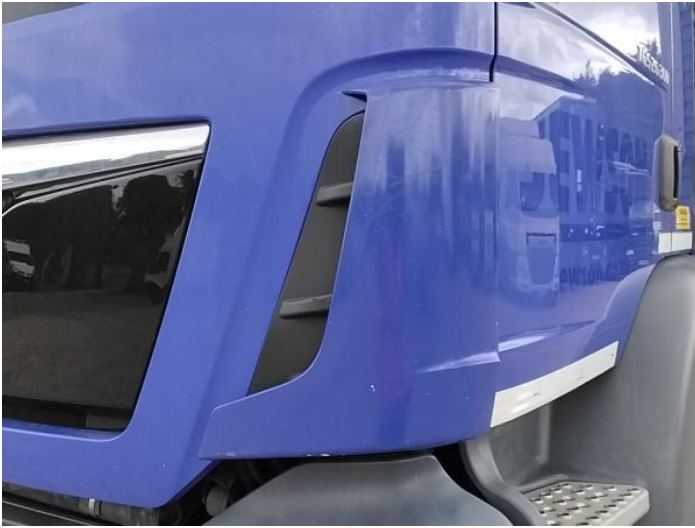
9: Wing nsf  
Chipped  
Multiple Chips

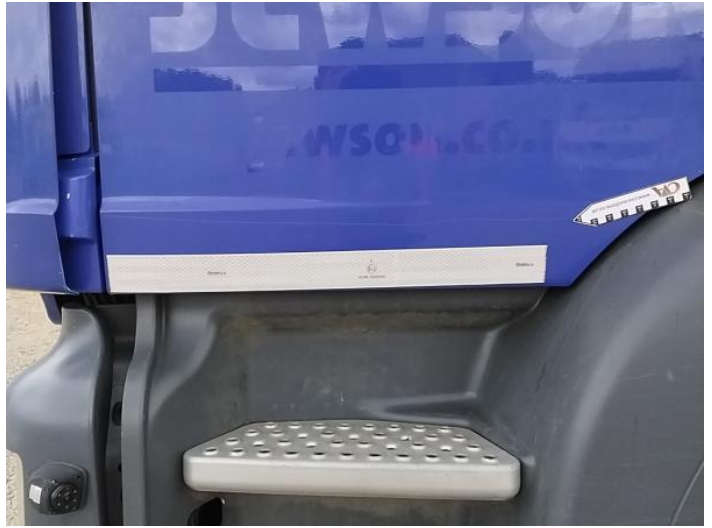
10: Door nsf  
Scratched  
Over 25mm Not Thru Paint

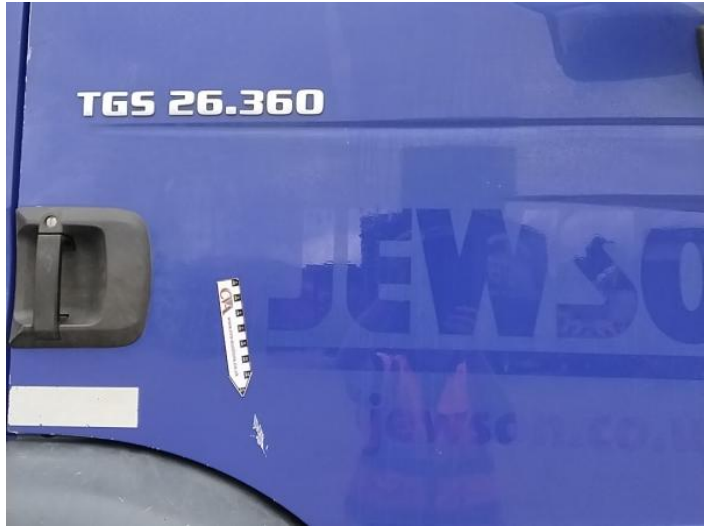
16: Door osf  
Scratched  
UpTo 25mm Thru Paint

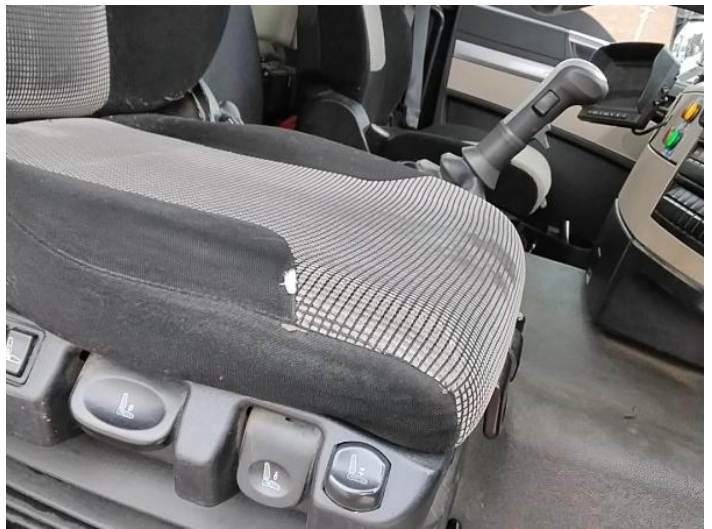
18: Seat Base Cover osf  
Holed  
Over 3mm
